Assessment of Landslide Event in Naltar Valley, Gilgit-Baltistan, Pakistan using Optical Imagery

Key words: Mass movement, Naltar, DEM, Satellite imagery.

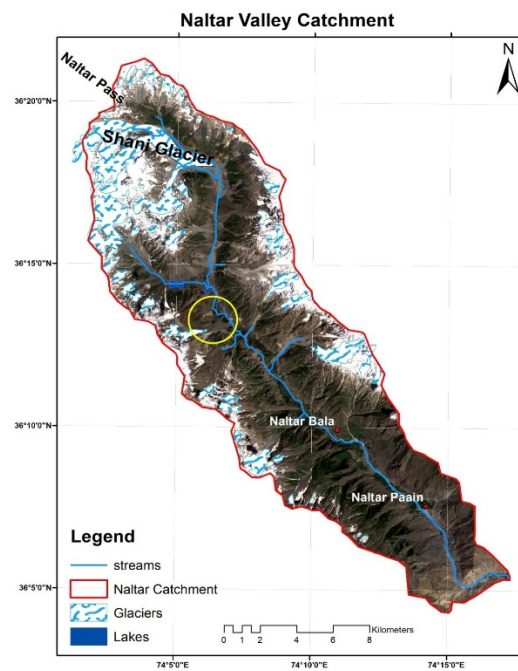
Figure 2: Naltar Catchment area. Shani glacier is the largest glacier situated in the north of the catchment from where the main river stream of Naltar valley originates and falls in Hunza river. Yellow circle shows the location of slide ridge and effected glacier. The location of two main villages of Naltar area also shown.

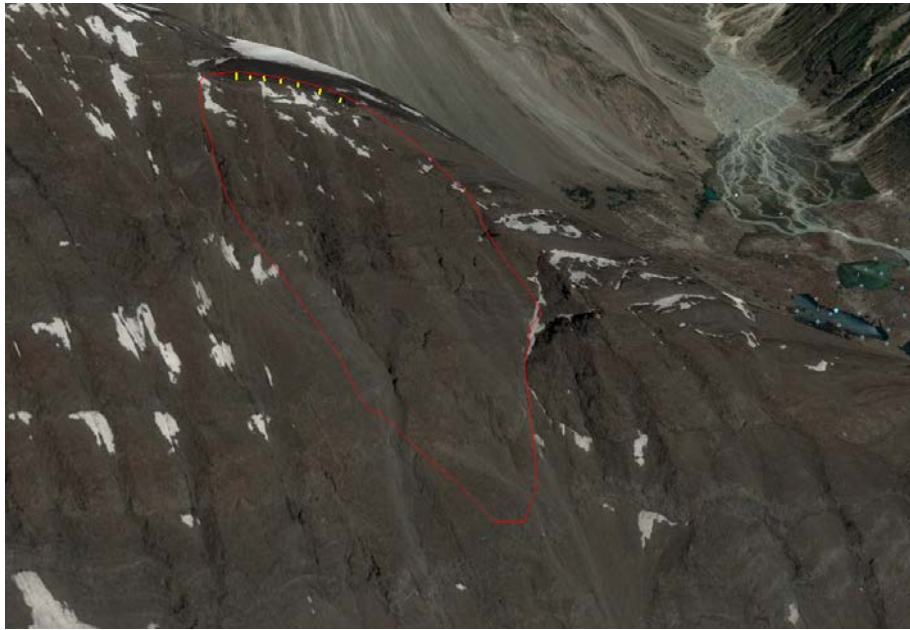
Figure 5: The red polygon is the slab that was detached and slides down eroding the flow path which finally accumulates at valley beds over Naltar river. The yellow lines show the estimated depth of slab from the crack to the surface of the slab part. The zoomed-in snap of this part is shown in Figure 6.

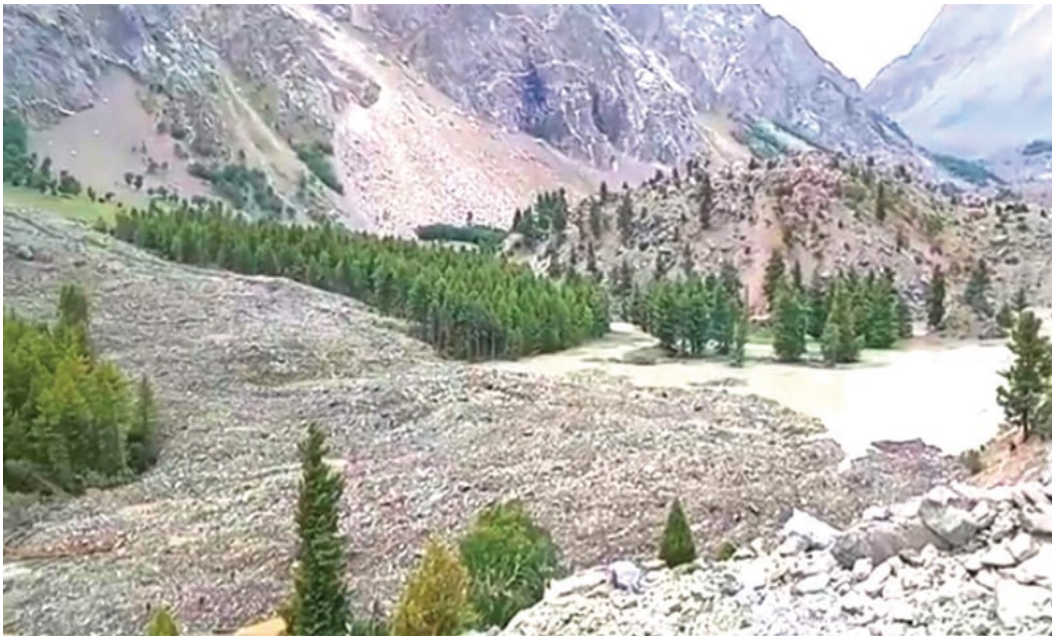
Figure 10: The accumulated alluvial fan and damaged forest. The height of the trees in remaining forest provide in insight about the fate of damaged trees and extend of erosion and accumulation debris thickness.
